GT2008-50791

THE USE OF EDDY CURRENT SENSOR BASED BLADE TIP TIMING FOR FOD DETECTION

K S Chana & D N Cardwell
QinetiQ Ltd
Cody Technology Park
Farnborough
Hampshire
GU14 0LX

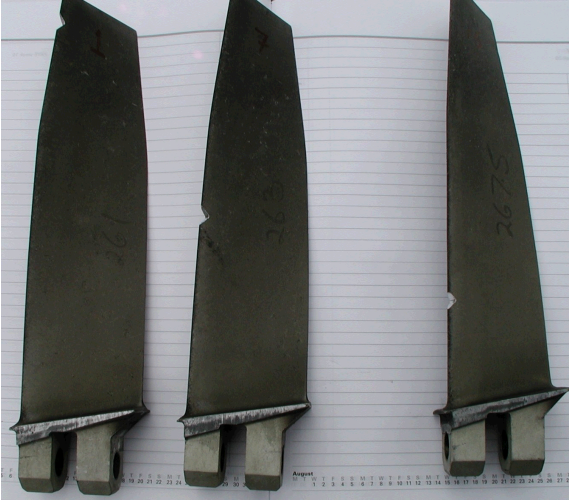
Figure 6: Damaged blades (Numbers 1, 7, 15) fitted to engine

Three second stage rotor blades (numbers 1, 7 and 15) were removed and artificially damaged in a similar manner to that expected in service, simulating FOD damage at three different span-wise locations. Figure 6 shows the three damaged blades. The damage was kept to the leading edge with blade one damaged in the top one third of the span by removing a wedge section of approximately 6mm width and depth. Blade two was damaged in a similar manner but near the mid-span. The third blade was damaged within the lower third of the blade and was kept to about 3mm. Tip timing measurements were taken over a number of cycles as described above on the stage two fan rotor with the damaged blades fitted.

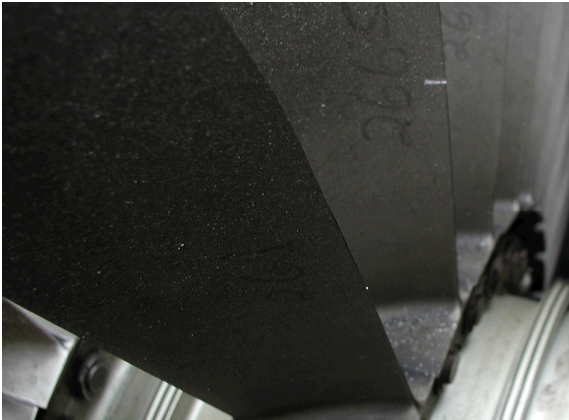
Figure 7: Damaged blade (Number 2) fitted to engine

Although some datum runs were carried out prior to damaging the blades, subsequently it became apparent that these were insufficient to carry out averaging between runs. Further in to testing it became apparent that more datum runs were required to obtain a better average, hence two more blades were damaged (numbers 2 and 20). Blade 20 was damaged at mid height on the leading edge with a 'V' cut to simulate FOD, and blade 2 at mid height on the trailing edge with a small slit, to simulate a crack. Following this the blades were re-fitted and more tests carried out. Figures 7 and 8 show the simulated FOD on these blades.

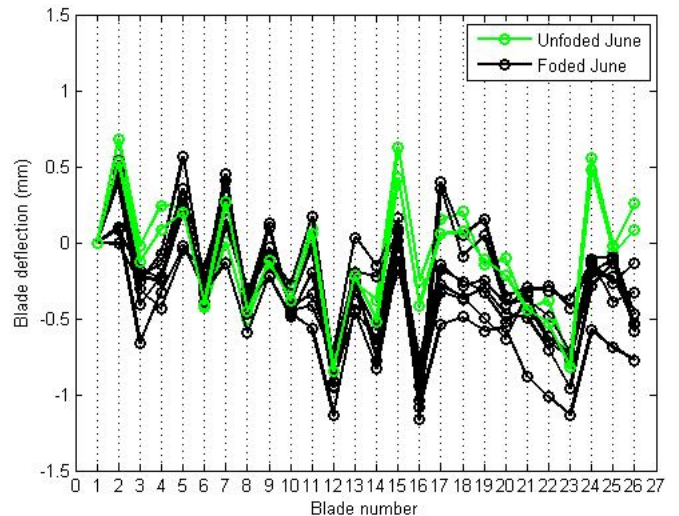
Figure 9: Average rev to rev deflection FODed and unFODed blades

The engine was then run over a number of test cycles and tip timing measurements obtained. Figure 9 shows a comparison of averaged rev to rev blade deflections at full speed over about 1000 revolutions. Each trace represents a different cycle and the plot contains data from both datum

and simulated FOD runs. These data were taken from eddy current sensor 2. The maximum average deflection is approximately ± 1 mm notably the results in this figure do not particularly identify the damaged blades however, there is a separation in the data on blades 4 and 24. These represent blades 7 and 1 respectively on the engine and are two of the three damaged blades. The third damaged blade, blade 15 appears on the plot as blade 12, although in this case there appears to be little effect on the blade position. In addition there is some separation on blades 17 – 21 (on the plot) but it is not evident on every cycle. Clearly the results from damaged and undamaged runs show that a change in the blades has occurred. Figure 10 shows the average of the traces in figure 9. This more clearly shows the separation on blades 4 and 24.

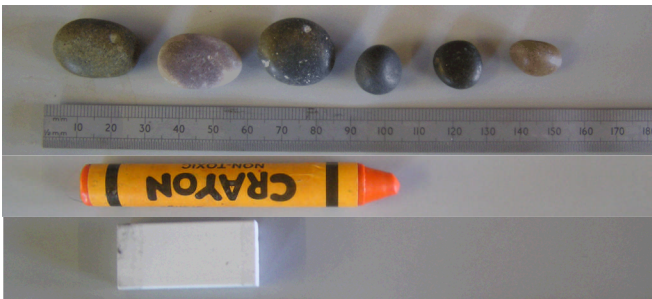
Figure 14: Foreign objects used for dynamic FOD

Foreign objects chosen were of three types, pencil erasers, crayons and small pebbles of various sizes. Although it was known from previous tests that damage would be sustained on the blades when stones are used, it was necessary to impact the blades sufficiently to produce an excitation that could be measured. A selection of the foreign objects used is shown in figure 14.

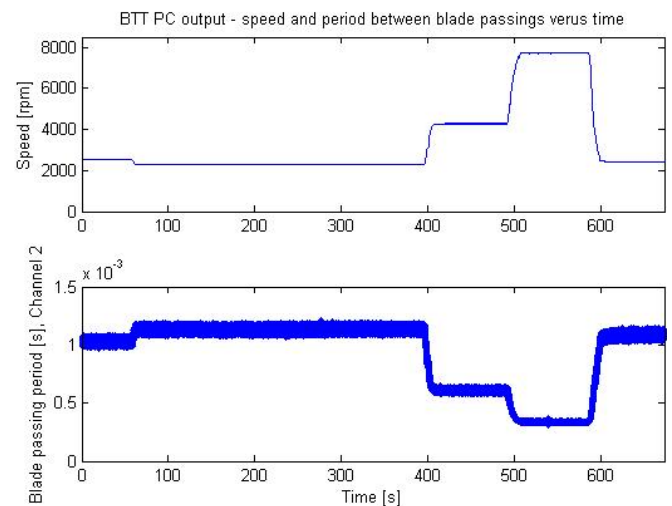
Figure 15: Speed plot and Eddy current sensor blade arrival time plot

Detection of the eraser being ingested into the engine was not possible and is therefore not included here. Figures 15 to 19 cover the data from a FOD test using crayons. Figure 15 shows an LP shaft speed trace together with a plot of blade arrival time interval from an eddy current sensor. The speed trace shows the run over which data were recorded. The engine starts at idle, then accelerates to approximately 4000 rpm before accelerating again to 8000 rpm and then decelerating back to idle. The FOD event occurs during the period at full speed. A disturbance is visible on the arrival time interval trace during this period which is caused by the FOD event at approximately 540 seconds. Figure 16 shows a casing vibration trace taken at the time of the FOD event and triggered by the event. These vibration traces are a good indicator of the timing of FOD events, but give no indication of which blades have been affected and the likely level of damage sustained. The vibration transducer was fitted directly above the first stator on the casing. Figure 17 shows a

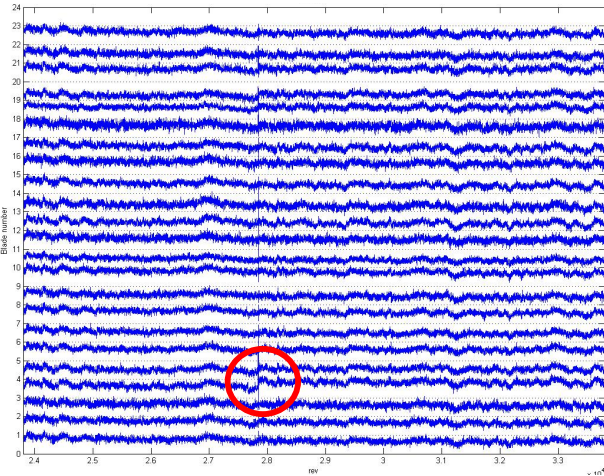
Figure 17 Waterfall plot showing FOD strike

waterfall plot for the same sensor for the period of the run at full speed. It can be seen that just before rev number 28000 on blade 4 that there is a disturbance which causes the deflection to shift dramatically for one rev and subsequently leaves the blade in a different average position. The initial disturbance marks the point and, the blade which took the main FOD impact. There are also smaller disturbances on most of the other blades at the same time. They may also be smaller pieces of the FOD (as it shatters) item as it is broken up and impacts other blades. It could also be, however, a slight disturbance on the once per rev signal, which is used as a reference. A closer inspection of the once per rev signal shows no evidence of any disturbance at this point in the run. Figure 18 shows the average and rev to rev blade deflection for the same period as covered by the waterfall plot (approximately 10000 revs) at full speed. The largest instantaneous deflections can be seen on blades 4 and 5. The deflections are calculated using a tip radius of 400mm, which is close to the actual value, although at 10mm this seems quite large, although it may be that the FOD impacted as the blade approached the sensor. The immediate effect of the strike lasts only three revolutions of the rotor furthermore, as noted in the waterfall plot, the blade takes up a slightly different average position after the strike. In addition many of the other blades show small deflections (much smaller) for a single rev, these out lying deflections as mentioned previously may be caused by a slight disturbance on the once per rev, which should affect all the blades equally, or because the FOD is broken into multiple pieces creating small impacts on other blades. Once again no noticeable disturbance can be identified on the once per rev signal.

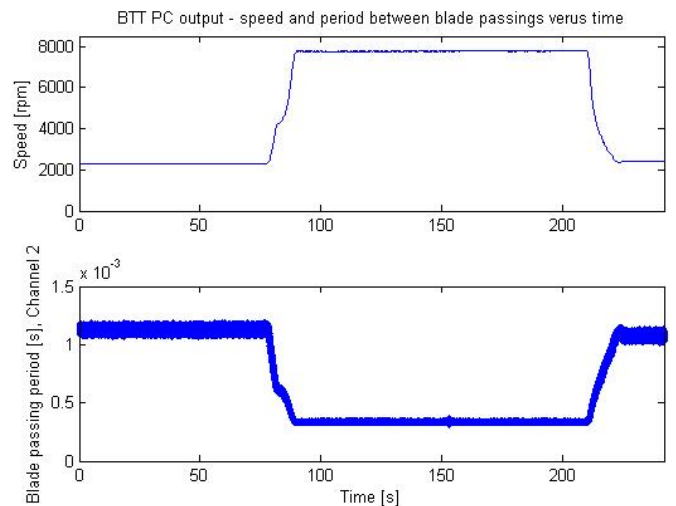
Figure 20: Speed plot and Eddy current sensor blade arrival time plot

Figures 20 to 24 show a similar set of plots for a test using a stone as the FOD item. Figure 20 shows the speed plot and blade passing interval. The lower plot contains blade passing information for all blades from sensor 2 and has no influence in this plot from the once per rev signal. The FOD event is apparent as a disturbance in the plot just after 150 seconds into the run.

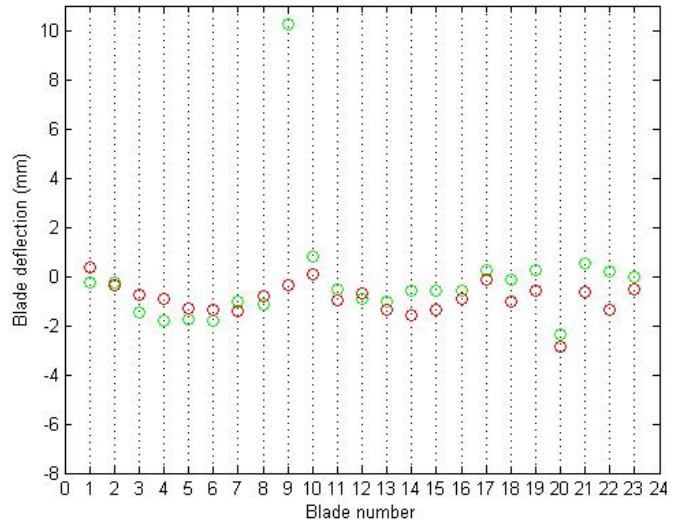
Figure 23 Average (red) and single rev (green) blade deflection

Figure 21 shows the waterfall plot for the portion of the run at full speed. The FOD impact is apparent on blade 9 at around rev number 12000. As in the previous example there is a sharp spike in the deflection of the blade after which its position and general level of deflection are altered. In this case however, there appears to be very little effect on the other blades. This is further evidenced in figure 22 where there is only a single outlier which, appears on blade 9, the blade that was struck with the foreign object. The strike is again clearly evident in figure 23 which shows the average and instantaneous deflection at the point of impact.
